**Fall Field Trip**  
**Association of Environmental & Engineering Geologists -**  
**Carolinas Section**  
**Western Branch of the North Carolina Section of the**  
**American Society of Civil Engineers**  
**September 6, 2014**

**Faults and Landslides - Geologic Structures, Processes**  
**and Landforms Important to Engineering and**  
**Hydrogeology Projects in the Blue Ridge of Western**  
**North Carolina**

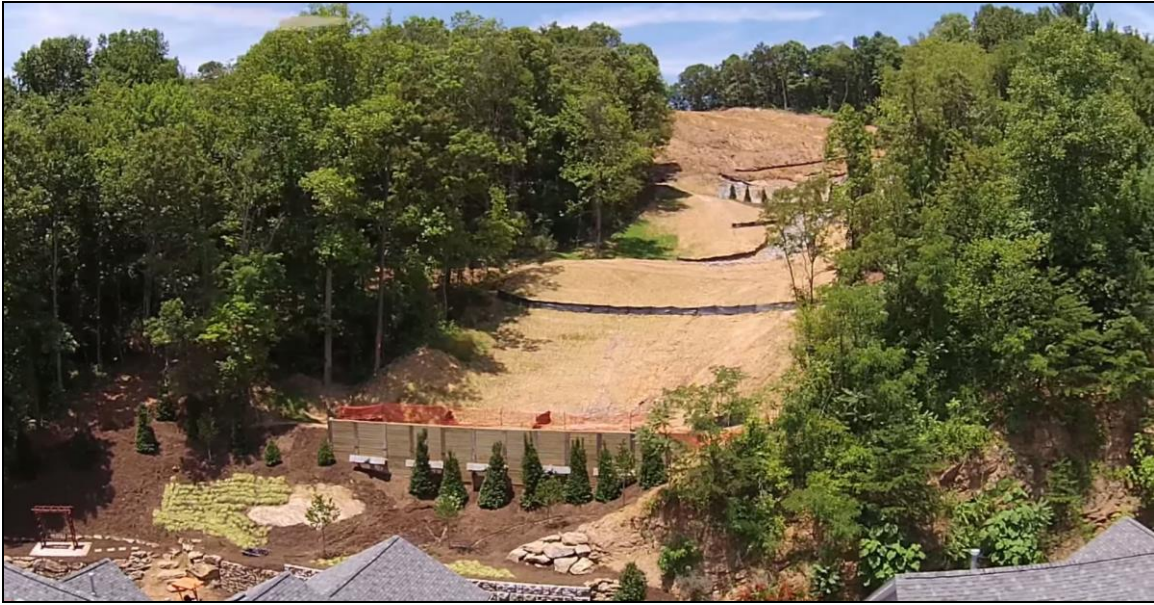
**Figure 2-3.** Oblique view of the slope stabilization at the Piney Mountain landslide.

The final design was in place by September, 2013 and construction began as soon as it was approved by the city in November. The design consisted of 3 tiered retaining walls. A lower block wall to replace the original small retaining wall behind the house, a large soldier pile wall a short distance upslope, and a soil nail wall midway up the slope. The tiered wall system was

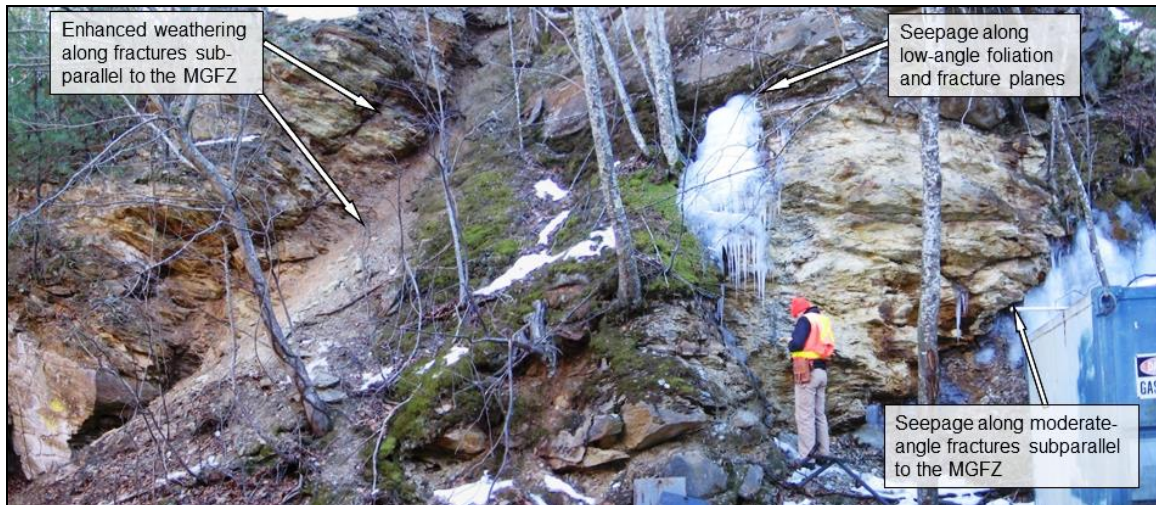
**Figure 4-6. Stop 4 Location.** Outcrop showing enhanced weathering along fractures parallel to the WNW-ESE trending Mills Gap Fault Zone (MGFZ). Ice indicates seepage zones along low dip angle foliation and fracture planes, and moderate dip angle fracture planes subparallel the MGFZ. These fracture sets can also influence the stability of rock slopes.

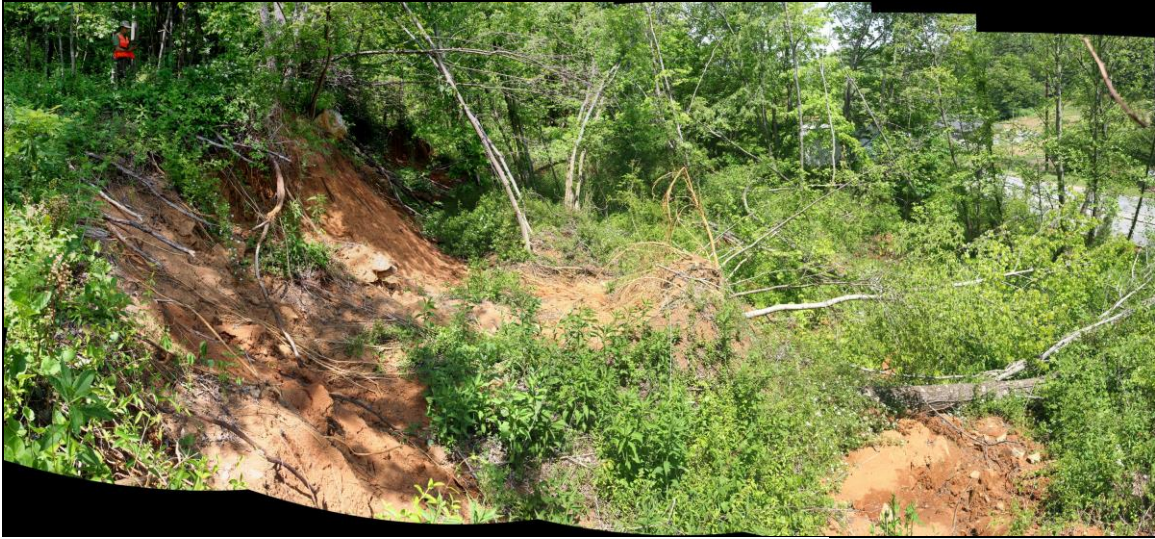
**Figure 5-3.** Scarps of the most active portion of the Lorraine Drive landslide.

From late summer 2012 through summer 2013, the NCDOT observed an increase in movement rate, which coincided with above average rainfall (Figure 5-3). The slope was laid back and 12 horizontal drains were installed Aug-Sept 2013 (Figure 5-4), which slowed the movement until December 2013. Since December 2013, the NCDOT maintenance division has needed to remove soil from behind the concrete barriers periodically. You will notice that all but two of the horizontal drains have been covered by recent movement.

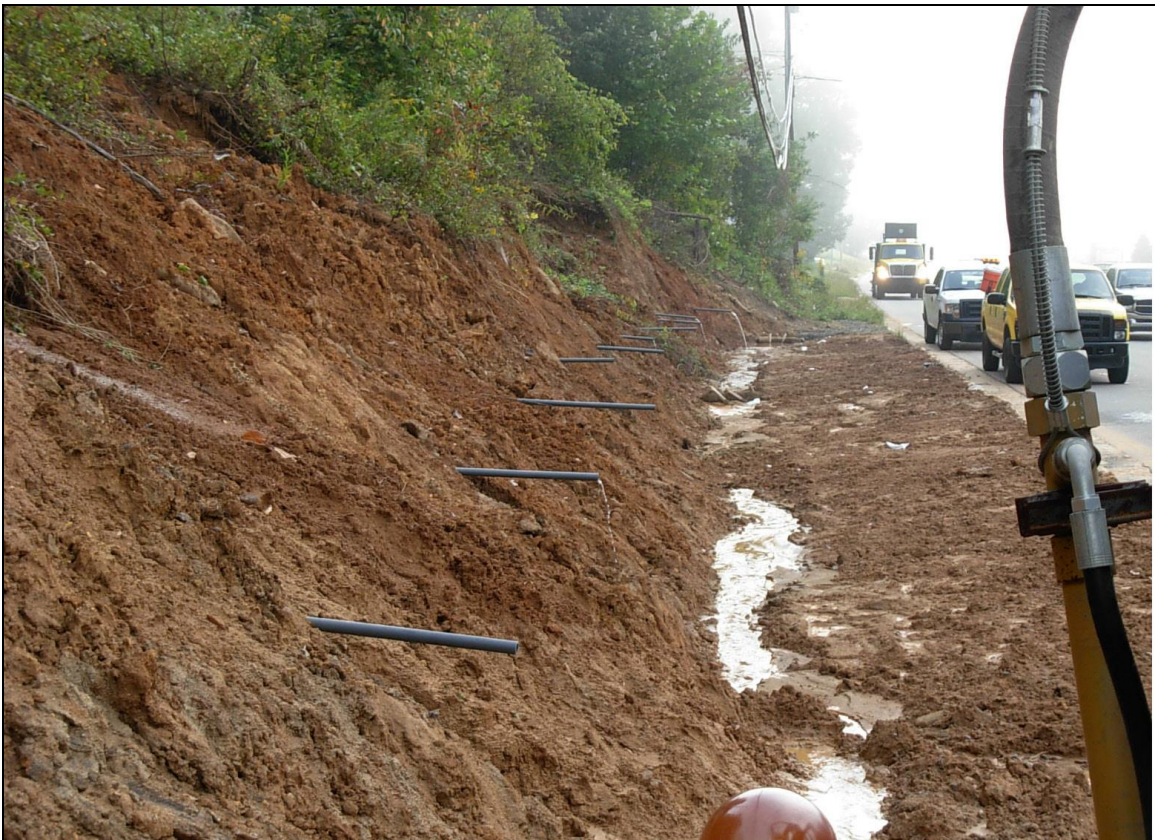
**Figure 5-4a.** Twelve horizontal drains were installed in September, 2013 by the NCDOT. Photo courtesy of the NCDOT.

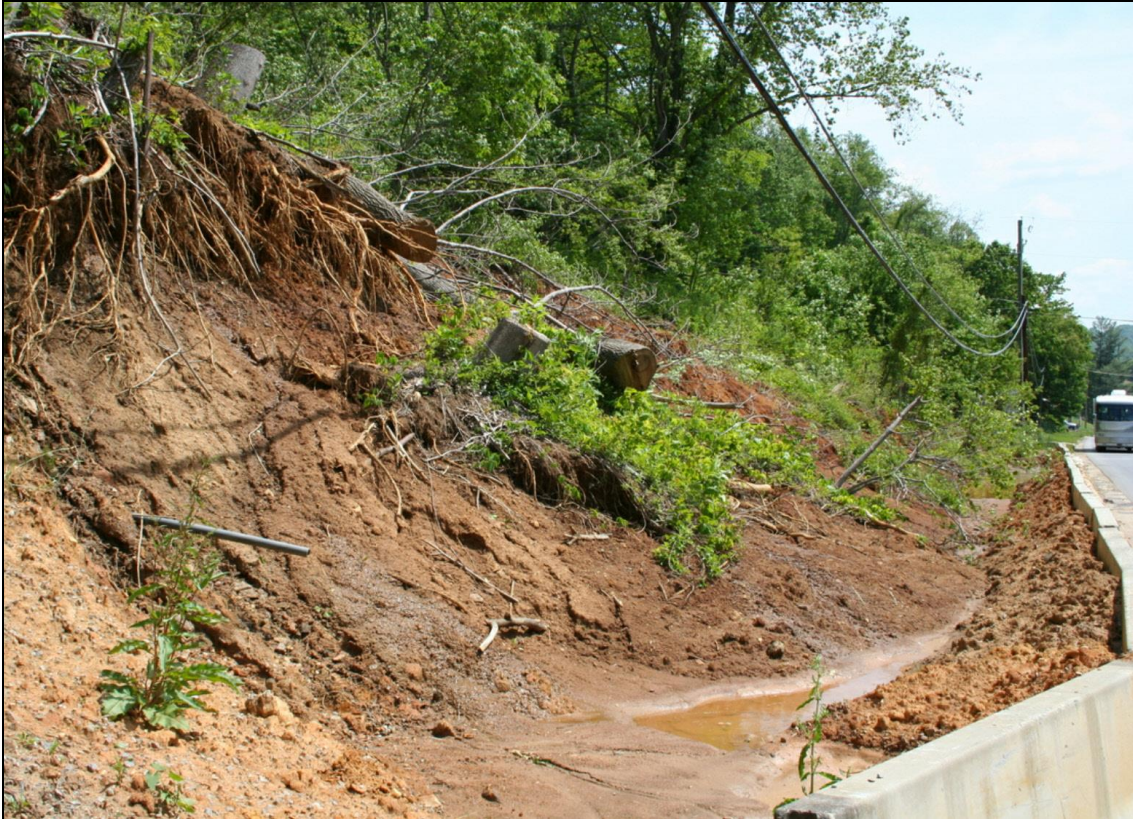
**Figure 5-4b.** Horizontal drains in May, 2014. The landslide has covered 10 of the 12 drains.
